CASE STUDY:

Cockroaches
and rodents in a
manufacturing plant

An automobile manufacturing facility was experiencing problems with both Norway rats and American cockroaches.

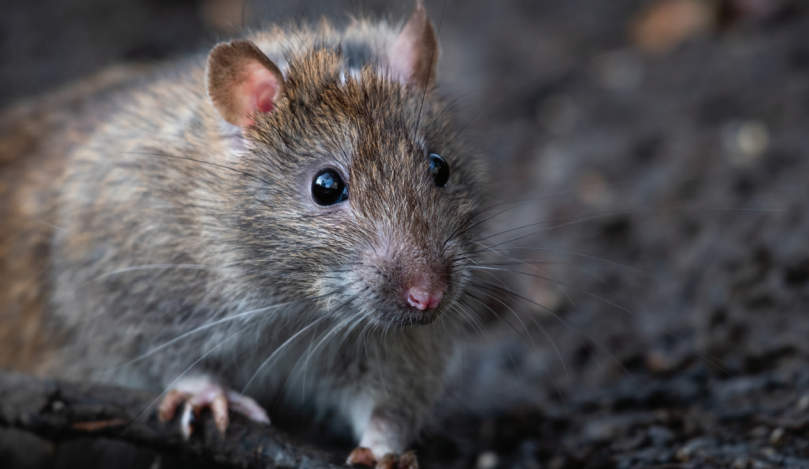
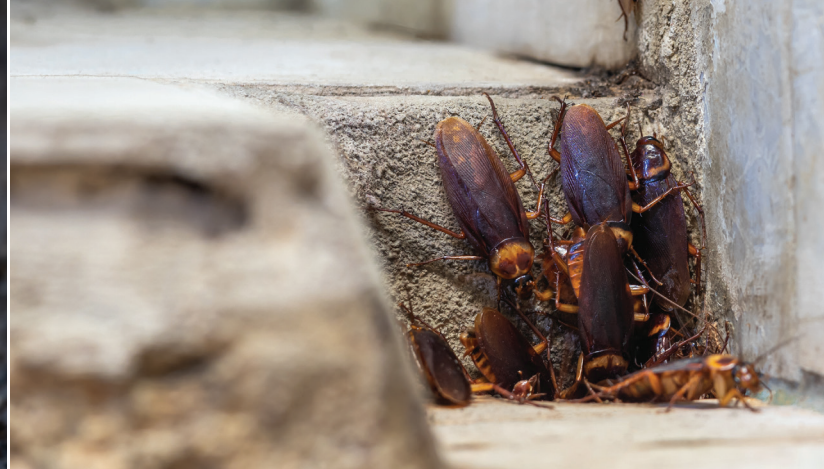
Upon investigation, it was found that both the American cockroaches and the Norway rats were entering the structure from exterior sources. The American cockroaches were harboring in the sewer system and making their way into the facility through drains and sump pumps located in employee areas like offices, restrooms, and basements. The Norway rats were based on the exterior but would occasionally enter the plant through poorly

sealed doors or doors that were left open by employees for ventilation purposes. Numerous burrows were found in one exterior location near a dumpster where employees often took exterior breaks. The majority of this exterior area was paved, except for a small grassy patch. The rats took advantage of the limited space for harborage. Food was available in the area due to trash left behind by employees, even when properly discarded.

Our Technicians directly treated the exterior areas where rats were burrowing by placing pelletized bait into the burrows. The team maintained the bait for a period of several days, closed the burrow openings, and monitored for the reappearance of activity. We recommended sealing the small grassy patch with concrete to prevent future rodent burrowing.

The service also included placing additional rodent bait stations along the building perimeter to

allow for continual monitoring and control as needed. Technicians pest-proofed the doors and educated staff on the importance of keeping doors closed while not in use. Acting on another recommendation from our team, plant staff added trash receptacles with self-closing lids to help decrease accessibility to discarded trash.

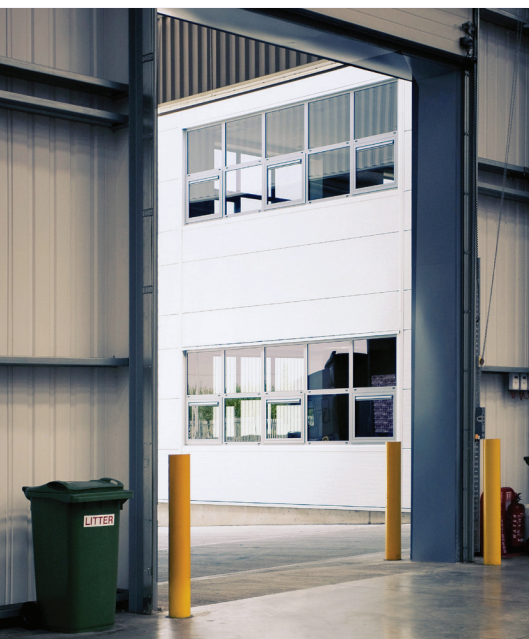
needed for water management be sealed. If a drain could not be sealed, the service team used insecticidal baits or installed drain screens or one-way valves. Based on the size and design of the drain, the American cockroach management plan called for use of granular or gel baits in drain treatment. The team placed granular baits on plastic-backed glue boards which were suspended inside larger drains and sump pumps and secured via wire onto grate covers.

To reduce future American cockroach activity, our experts requested that any drain not
